ARCHAEOLOGY AND THE BENNACHIE COLONY: EXCAVATION OF TWO 19TH-CENTURY CROFTS

Jeff Oliver

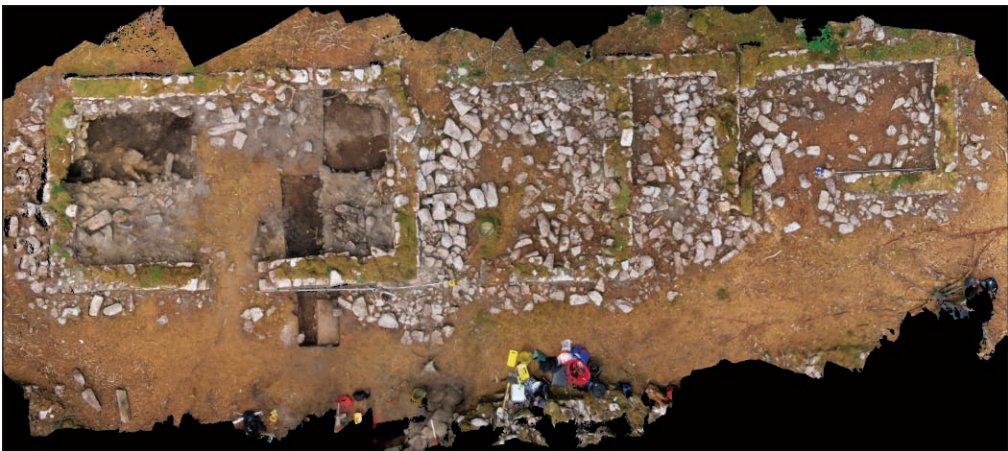
Figure 2. Aerial view of Shepherd's Lodge showing excavation units.

The investigations described here focused on the oldest and largest apartment (with exterior measurements of 9 x 5.4 m), which at one time would have been a freestanding cottage. Due to time constraints, the excavation strategy focused on clearing the internal areas of rubble and then opening up smaller excavation units (sondages) in the structure's interior and forecourt areas.

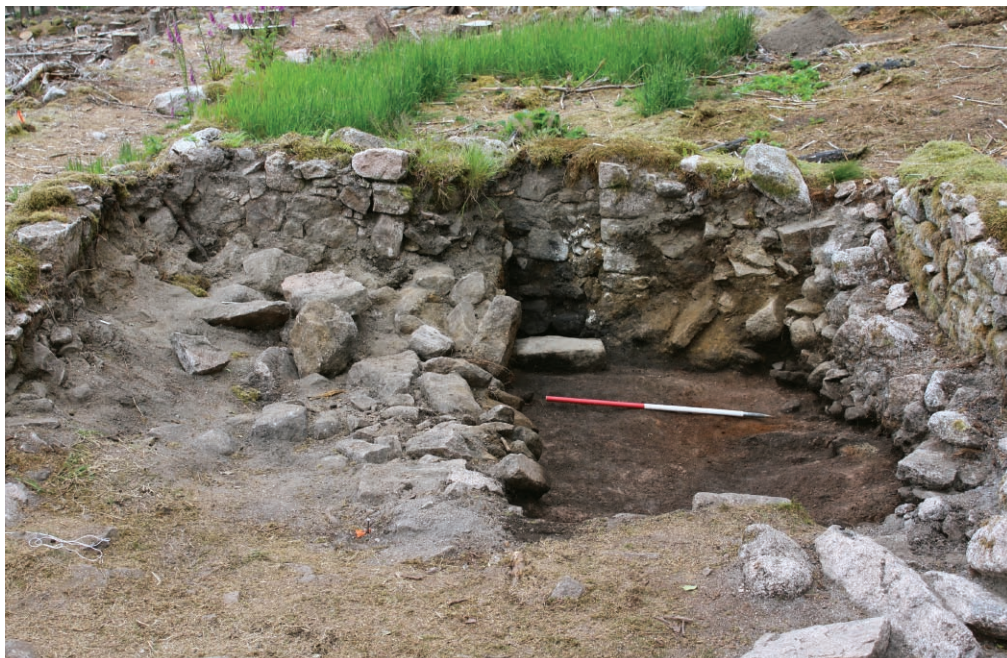
Figure 3. Showing the west side of Shepherd's Lodge and Sondage 1 in the northwest corner. The fireplace can be seen against the wall along with remains of the gable end and chimney.

This excavation unit (2 x 1.5 m) was located in the northwest corner of the structure and focused on further uncovering the fireplace and in the hope of revealing the 19th-century living floor. At the base of the fireplace a hearth flagstone was discovered along with possible evidence of wall mortar. No evidence of a floor was found in this area, despite the excavation reaching a level deeper than the hearth flags. The excavation terminated at a reddish brown deposit, which was determined to be well below the possibility of a living surface. Notably, a conspicuous burning layer of dark brown to black soil with charcoal inclusions

several centimetres thick was discovered along the entire length of the north wall of the sondage immediately below the level of the exposed hearth. A modest number of artefacts, mainly small ceramic sherds, were also discovered.

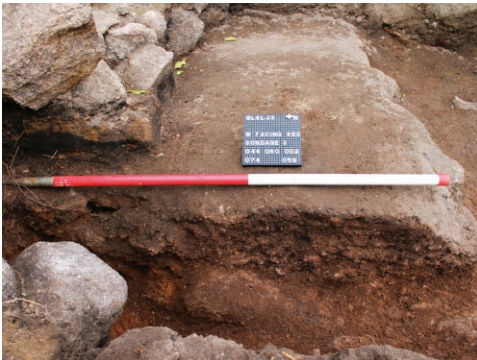
Figure 4: Sondage 3, showing the remnants of the 19th-century earthen floor.

A further excavation unit (2 x 1.6 m) was dug in the northeast corner of the structure to examine variation in this area. Excavation revealed the only clear evidence of a former floor, or living surface, which was discovered as a hard-packed layer of earth. Further excavations revealed that what remained of this former surface was restricted to a small area (1.3 x 1.2 m), the remainder having been dug out, likely during a later phase of reuse. The burning layer noted in Sondage 1 was also found along the north sides of the excavation unit. Excavation in this area also confirmed that the dwelling had no second fireplace in the east wall.

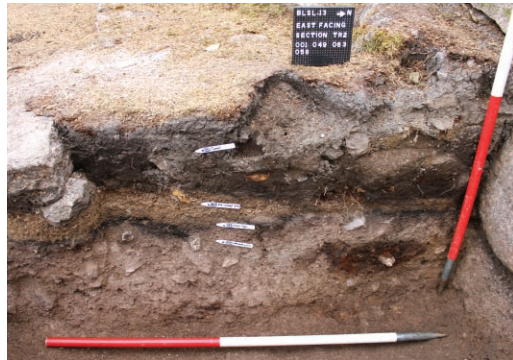
Figure 5: Trench 2 showing trackway stratigraphy and base of the south wall of Shepherd's Lodge overlying a relict topsoil layer.

This excavation unit was located outside the dwelling to the right of the doorway, immediately against the outside wall. It was planned to investigate the construction technique of the building and to discover the subsurface nature of the track way, which runs along the dwelling frontage. The excavation unit revealed no foundation trench for the wall on this side of the dwelling; instead granite blocks were placed on top of a thin dark layer of relict topsoil, a natural layer that is seen across the Colony. The track way was formed through the deposition of a light brown construction layer over this same top soil layer to level the area in the forecourt.

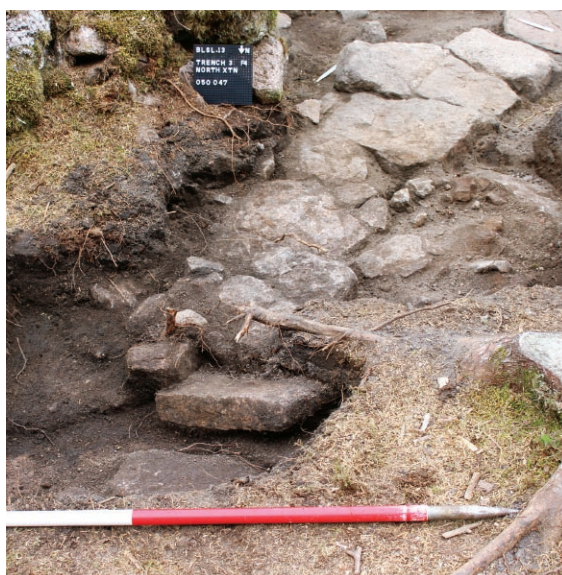
Figure 6: Trench 3 showing paved area in forecourt of Shepherd's Lodge.

This trench was placed to discover more about the forecourt area of the structure, and in particular a large levelled projecting platform opposite the house frontage, which is enclosed by a drystone dyke. Excavation disclosed a large number of ceramic artefacts formed in a midden against the dyke. This may represent a principal dumping place for rubbish discarded or swept from the dwelling. A series of irregular flagstones was also discovered in this area and may have served as paving along the margin of the platform.

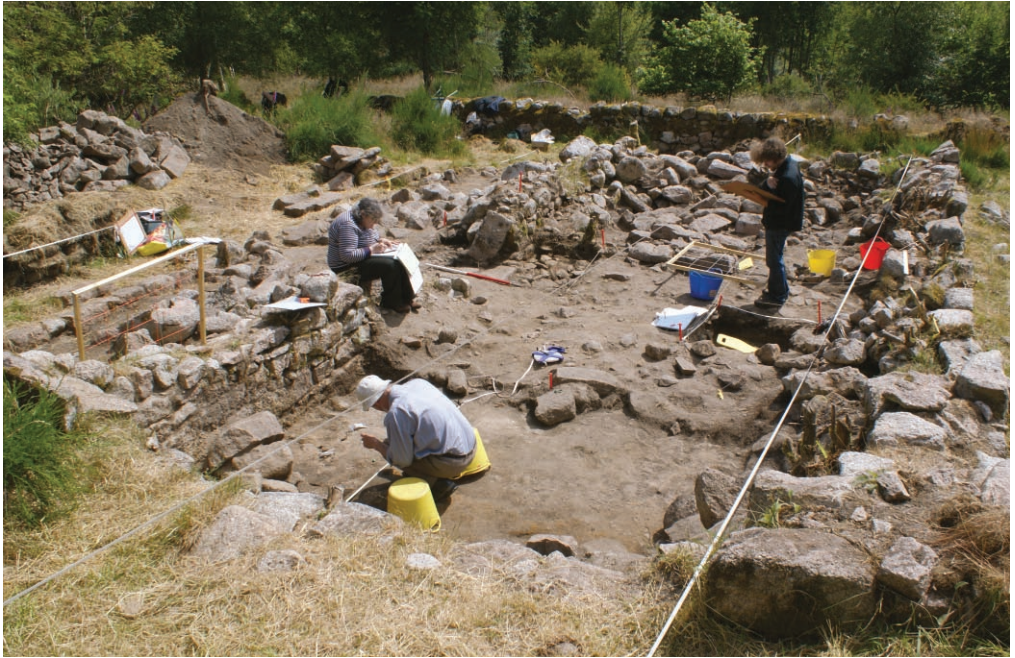
Figure 7: View south over Trench 1, the interior of the McDonald House.

The excavation of the house proceeded with removing the rubble of the collapsed gable ends and side walls from the interior of the building. Due to its weight and bulk, the collapsed masonry posed a significant challenge to remove. The solution was engineered by our community researchers and inspired by the past: the use of a 19th-century style timber stretcher (traditionally used for moving quarried granite) provided the means. As at Shepherd's Lodge, sections of the gable ends, represented by preserved courses of masonry, were recorded near the centre of the building, helping to confirm that the walls had been pushed in from opposite sides. As the masonry was being removed in the northwest corner, a dark organic-rich deposit with a clayey consistency (0.35 x 0.30 x 0.09 m) was found overlaying building debris and interpreted as a preserved roofing divot. A single leather shoe, thought to be that of a child's, was found within the collapsed remains of the north gable end. A similar discovery was noted during the excavation of the dwelling house at Cairn Cootie (Bogdan *et al*, 2000, 20). The interior of the McDonald house produced a substantial fireplace, which was built into a recess in the north gable end. This was composed of a v-shaped stone firebox flanked by cheek stones, which sat on a substantial stone-flagged hearth. More unexpectedly, excavation exposed a considerable quantity of artefacts, notably the remains of whole ceramic vessels, such as a Rockingham teapot, which were found toward the bottom of the rubble layer. Further artefacts were found in association with the fireplace, including

crushed white earthenware plates and vessels of various types of decoration, as well as metal hooks and glass fragments. Once the dwelling was cleared of building debris, sondages were placed in three different areas of the structure to explore subsurface remains (Figure 7).

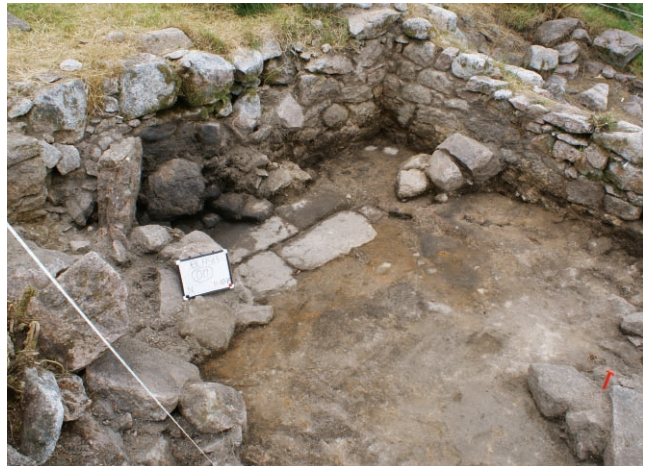
Figure 8: Kitchen area with fireplace, exposed in Sondage 1.

This excavation unit (3.2 x 2.7 m) was placed at the north end of the dwelling and focused on exposing the area around the fireplace. This area is thought to have been contained within a single room, probably a kitchen. The unit revealed a large hearth made of stone flags in front of the fireplace

and a cobbled surface overlaid by hard packed soil: clear evidence of a built floor. Remarkably, unlike the well-swept floor of Shepherd's Lodge, much of the living surface was scattered with metal and ceramic artefacts, with a significant portion representing crushed whole vessels. Further excavation into the cobbled floor suggested this built layer was set into a base layer of construction fill.

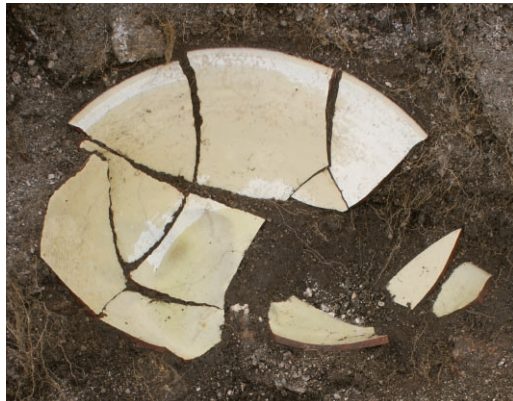
Figure 9: Crushed dairying vessel in Sondage 2.

A second smaller unit (1.80 x 1.6 m) was placed along the west wall adjacent to a window, which is indicated by a single lintel stone. The window may have lit a narrow hallway between two rooms (a point returned to below), though no evidence of interior separation was found. Notable finds included two crushed dairying vessels, one stacked inside the other and a miniature ceramic sheep. Further evidence of the cobbled floor was revealed here and a further test slot in the northeast corner of this unit revealed the same construction methods identified in Sondage 1.

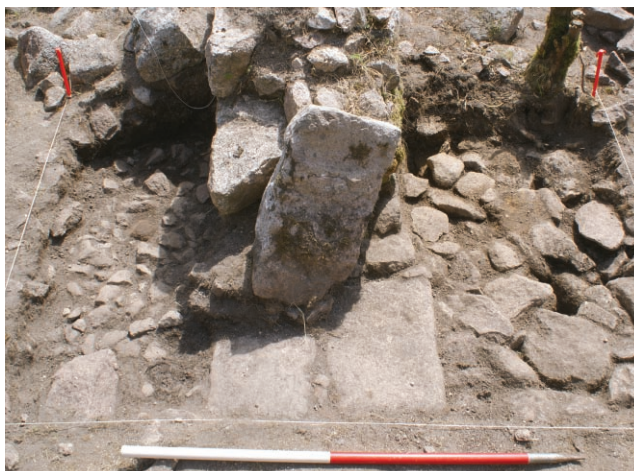
Figure 10: Sondage 3 showing comparison of exterior cobbled forecourt (left) with interior cobbling (right). The dwelling threshold is at the centre.

This excavation unit (1.2 x 2.0 m) was placed in the dwelling threshold and was focused on revealing the threshold area and to see whether external paving could be located in the forecourt. A floor of irregular, widely-spaced cobbles was identified in what is interpreted as the hallway area of the dwelling interior, while the exterior revealed an area of smaller

tightly packed cobbling: a paved forecourt. A slate object, possibly a whetstone, was associated with this feature.

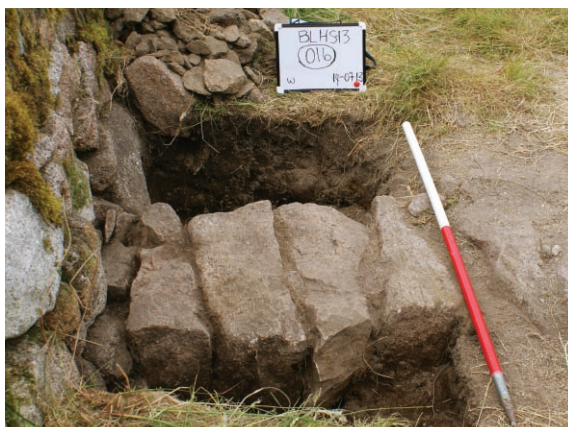
Figure 11: Trench 2 showing possible stone footing.

A final excavation unit (0.9 x 0.7 m) was placed outside the dwelling where it was intended to investigate an earth-fast feature initially assumed to be a stone-capped drain. The feature leads away from the southwest corner of the cottage across a cart track and terminates at a stone dyke. The trench revealed a row of solid granite blocks (each

approximately 0.6 x 0.35 x 0.20 m). Test slots excavated on both sides suggest the stone alignment was not a drain as the stones sit firmly on glacial till. While we were unable to excavate the corner of the dwelling, where it emerges, a possible interpretation is that it functioned as a stone footing to keep the house from subsiding or the walls from shifting.
