ECOLOGY AND LANDSCAPE-USE WITHIN THE  
PRE-MODERN LORDSHIP OF FORBES:  
INTERIM REPORT ON EXCAVATIONS AT DRUMINNOR CASTLE,  
2012 AND 2013

Colin Shepherd, David Irving, Angela Groat and Iain Ralston

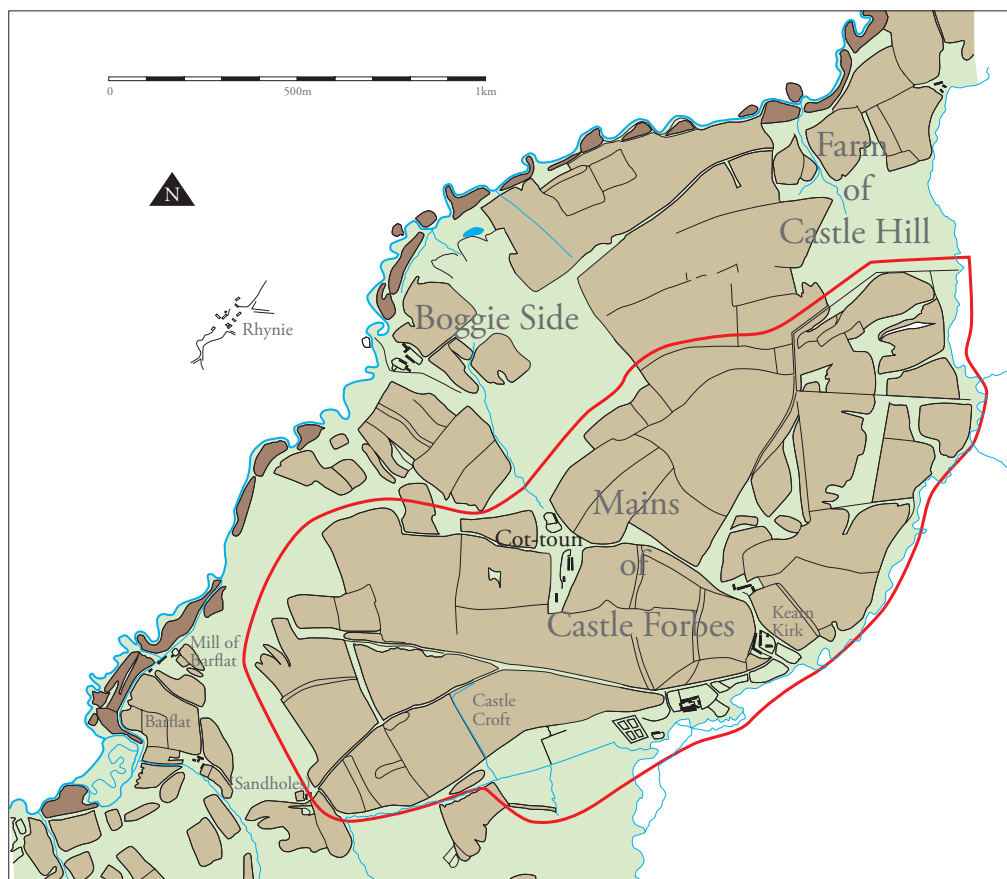
Figure 1. Estate plan of 1771 showing Druminnor and its surroundings (RHP 260-1).

Figure 1 shows the landscape setting for Druminnor Castle as given by an estate plan drawn c.1771. Documentary evidence indicates that certain settlements noted on this plan had not been in existence for very long. Of particular relevance are the cases of Boggieside and Cot-toun. Castle Hill, the Mains of Druminnor and Barflat - mill and toun - were present in 1552. But, that was all in this northern part of the estate. Cot-toun and Boggieside appear in the 1696 poll return, though the former is absent from the 1740 rental. The Barony Book also reveals, through identifying a witness in a case, that Cot-toun was in existence in 1665 and Boggieside, a little earlier, in 1660. We are told, moreover, that Boggieside was tenanted rather than being a simple settlement of cottars or grassmen. This distinguishes it from Cot-toun which, as its name implies, was an abode of cottars. Further detail revealed by the 16th century rental notes that the Mains of Druminnor were ‘in my lords hand’ and that there were a number of ‘croiftis maid furth of the Mains’. What this seems to be saying is that c.1550 the Mains was being managed as ‘demesne’, that is, directly managed by the estate rather than being leased out ‘on farm’. The ‘croiftis’ are said to have been carved out of the lands pertaining to the Mains, though whether this was recently or at some unknown period in the past is not stated. Most of these were held for the desultory sum of six poultry. Comparison with other rents paid on the estate suggest that their value could never have paid for an area of land capable of sustaining anything. In other words, these people must have been receiving their ‘living space’ in return

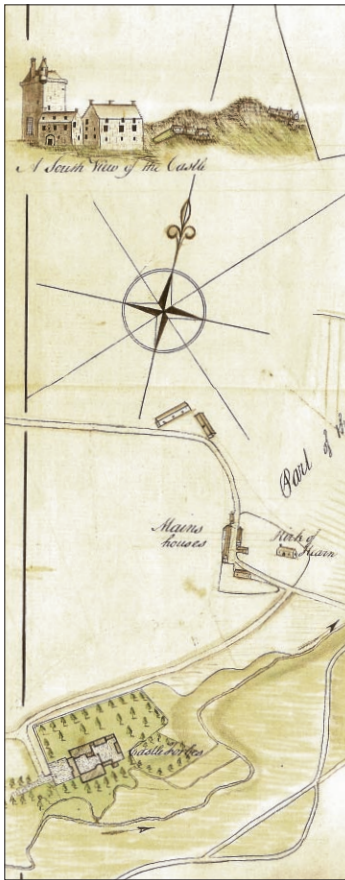
Figure 3. Portion of an estate plan (RHP 44705) showing footprint of castle in bottom left and visual depiction in the top left corner. (Reproduced by kind permission of Lord Forbes).

The key aims of the 2012-13 excavations were: first, to see whether there were any remaining traces of the 'footprint' of the castle as recorded on an estate plan of the 1780s (Figure 3); second, to understand their location in relation

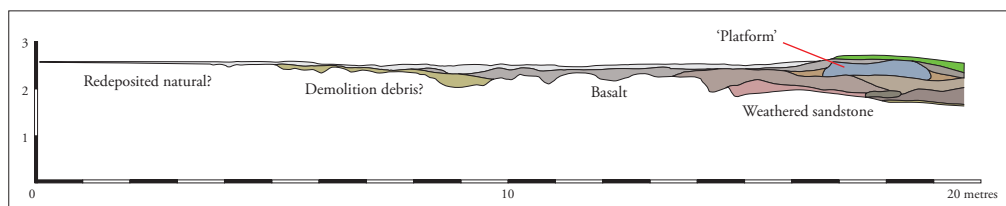
Figure 5. Section drawn of Trench 1.

Trench 1 (see Figure 5) was cut 1m wide and 20m long. It crossed the courtyard perpendicular to the tower of the palace building, over the car parking area and into the grass bank beyond. Excavation involved removing the surface layer of the trench until the upper level of the context below was revealed. The northernmost

zone of the trench revealed an unexpected and unusual rubble platform at a depth of around 20cm. This was composed of freshly quarried granodiorite packed into a dense matrix. Stratigraphically it overlaid almost everything and appeared to be associated with nothing other than 19th century material and demolition debris. It was sealed by a dense, gritty layer that appears to have been a levelling layer occurring extensively across the site. One possible explanation might be that it provided a platform on which cranes and winching gear could have stood when the castle was being taken down at the beginning of the 19th century. Much of the stone is likely to have been sold off. Across the remainder of the trench, just a few centimetres below the current ground level, it appeared that natural rock was encountered. No occupation debris was apparent throughout this trench apart from within a topmost levelling layer of waste material and hardcore. The finds included glazed pottery and earthenware, clay pipe stem and bowl, bone, brick and glass, all of which are of 19th century origin. The lack of stratigraphy and surviving deposits appeared to indicate that the area had been scoured, either when the castle was being demolished or in the twentieth century when the courtyard was being developed as a car park. Beneath the platform at the northern end of the trench, the natural subsoil fell steeply and a greater depth of potential stratigraphy was noted. This area is now under investigation and the findings will be published in due course.

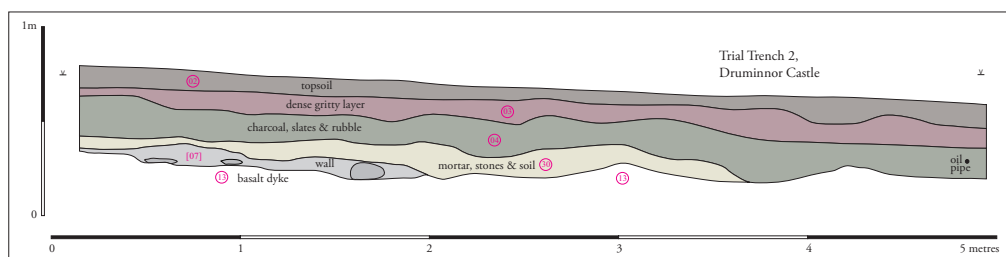
Figure 6. Section drawn of trial Trench 2.

Trench 2 (see Figure 6) was initially cut 1m wide and 5m long in an east-west direction. It revealed a clear stratigraphy with several contexts. Of particular note was a very heavily compacted burnt, deposited layer (04) and a deeper and also

compacted deposit of building rubble (030) which included iron nails and broken slate. This is believed to have been deliberately scattered and levelled over the site during the construction of the Victorian wing. Finds from the deposits above the the wall structure [07] were all of nineteenth century origin, consisting of bone, glazed pottery, earthenware and shards of glass. At a depth of approximately half a metre, trowelling revealed evidence for a mortar-bonded wall and cobbling, both of which were at a similar depth to the basalt dyke material (13). Both appeared to be embedded into it. The dating of the wall and cobbles remained problematic at this point as no artefacts were found from *in situ* deposits. The structure was presumed to be of eighteenth century date owing to its method of construction. It was considered that it may be one of the courtyard structures shown on the estate plan.

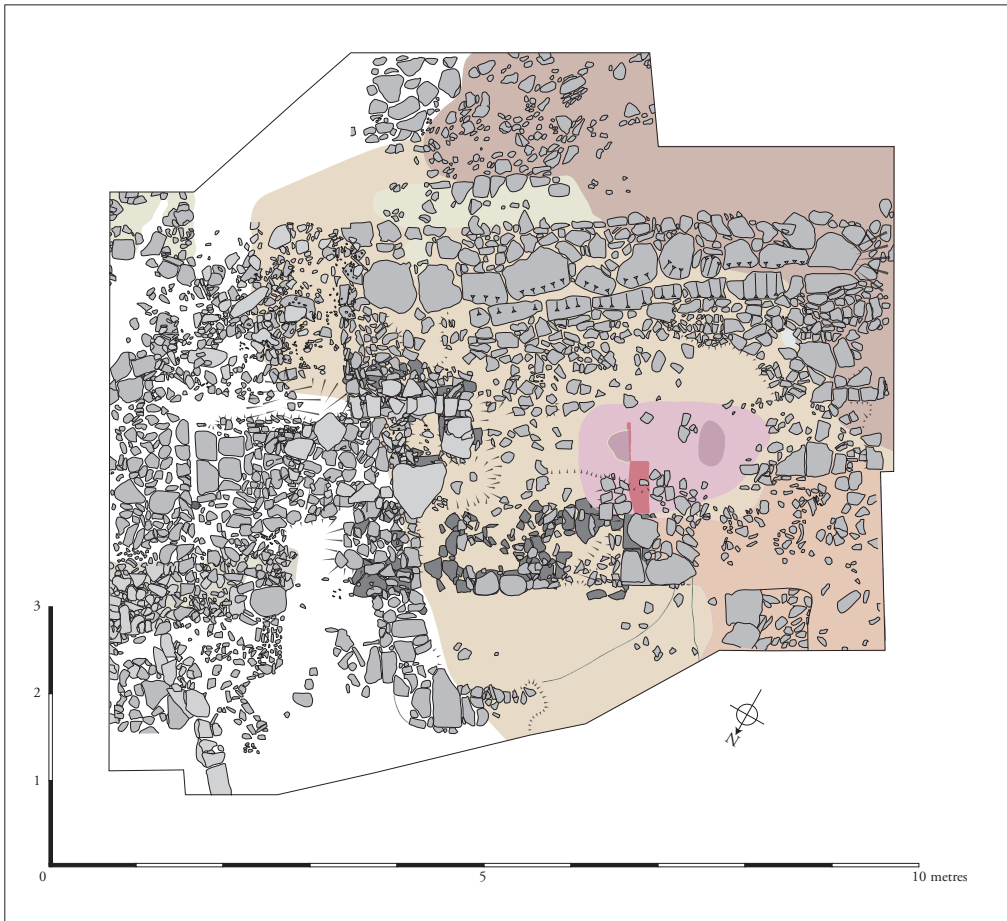
Figure 7. Trench 2 showing all remains.

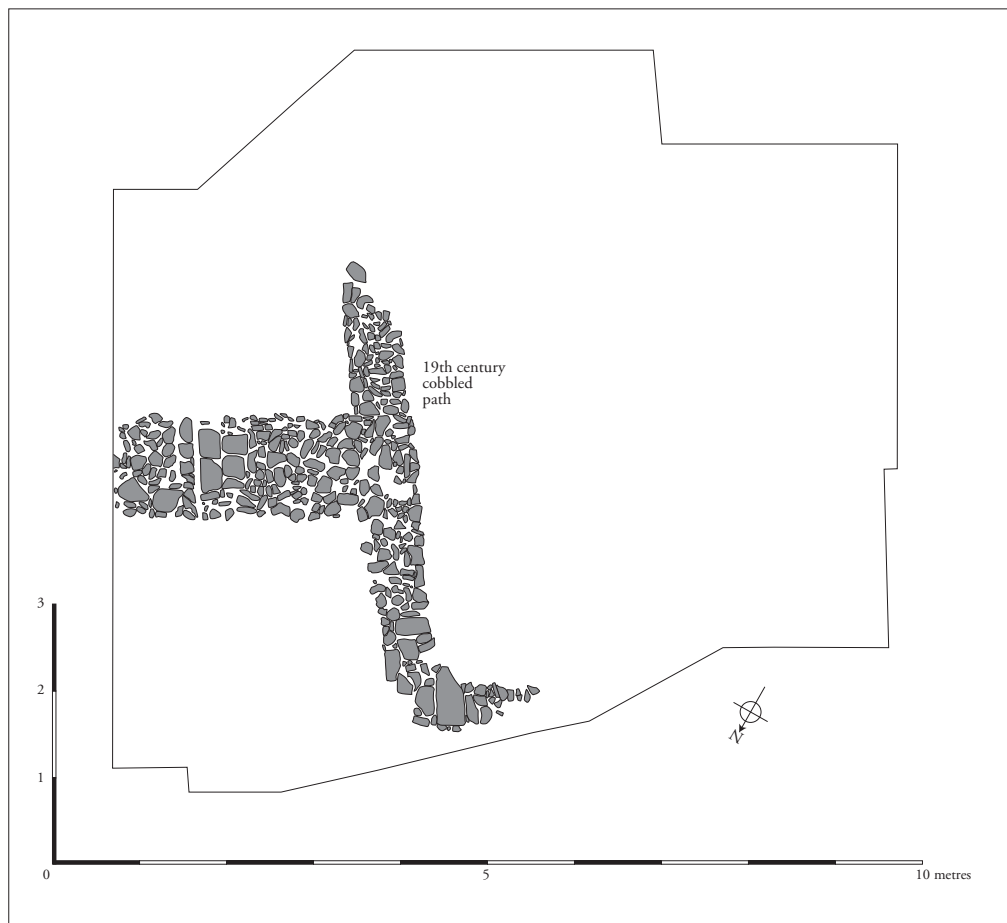
Figure 8. Early 19th century features.

*Early 19th Century (Figure 8)*

The stratigraphically latest features lay immediately under demolition debris that has been assumed to be a product of the mid 19th century construction of the Victorian ‘mansion’ sited at the west end of the existing 15th century hall range. The finds were consistent with a mid century date and not, therefore, deposited during the demolition of the castle that occurred at the beginning of the century. The cobbled surfaces appeared to have been edged by small stones that could not have surrounded a cultivated area. It is suggested that these paths ran through lawns. At its eastern projection a well-constructed gulley suggests an entranceway with timber threshold. No evidence of a stone super-structure was apparent and this may, therefore, indicate a simple timber garden structure.

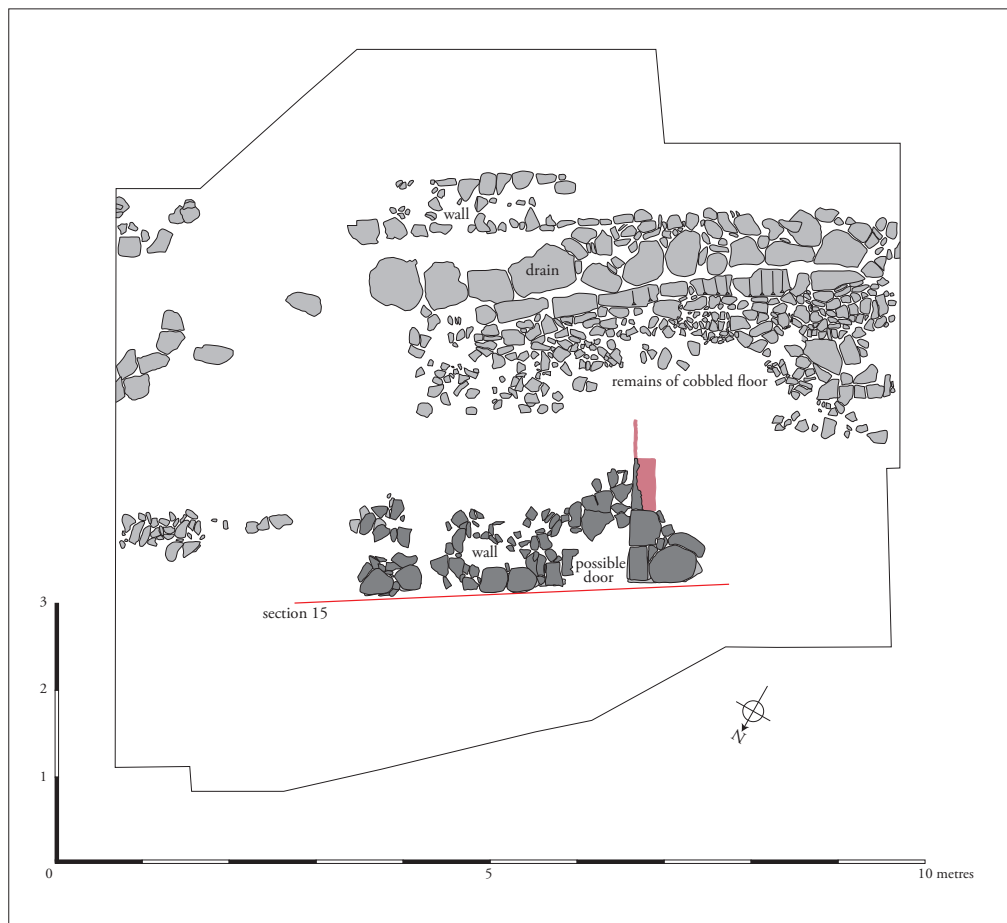
Figure 9. Late 18th c. features.

*Late 18th Century (Figure 9)*

This is the period whence the estate plan derives and the remains illustrated in Figure 9 suggest a successful completion of the project’s initial aim. The features shown would appear to be those present on the estate plan prior to the demolition of large parts of the castle. The wall at the top of the figure was strongly bonded with mortar. The same applied to the small section remaining on the same alignment in the top left of the plan. This wall would have faced onto the courtyard of the castle. Abutting this on its north side was a kerbed area of well-laid cobbles. Only a portion of this survived, although it sealed an earlier beaten-earth floor and hearth beneath. The alignment of the drain may be slightly askew when compared to the wall and it is suggested that this may have been a re-used feature. There also seems little point in having a drain on the inside of a building and this type of structure would appear to be more suited to removing rainwater from the exterior of a structure. Suggestions regarding an internal drain for animal waste does not seem workable in this instance.

North of the cobbling was a further wall with a possible entrance way that was, presumably, the main external wall of the castle enclosure. This wall was not mortared in the same way as the one to the south and its construction was, in fact, quite flimsy in comparison. Its construction is not, however, out of keeping with that noted for the barmkin wall at Craigievar where the wall was placed upon the original ground surface with no foundation trench and no evidence for bonding (Greig, 1993, 388; 391). Craigievar was completed c.1626 and this date would not be out of keeping for the remains noted here.

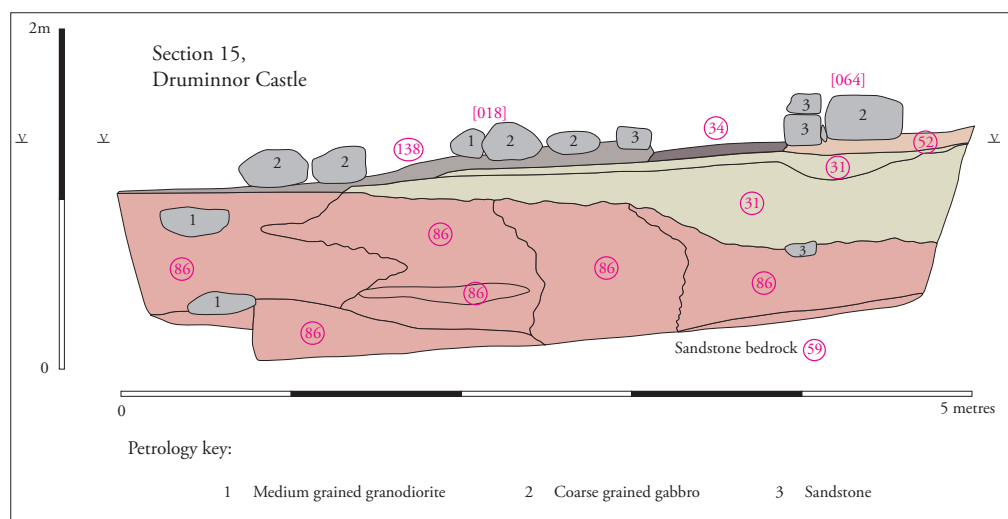
Figure 12. Section through site make-up material. (See Figure 9 for location of section).

support the underlying sandstone debris noted above and shown in section 15 (Figure 12). As it was sealed by the soils containing the 15th/16th pottery, it is likely that it pre-dates that period. It is noteworthy in this respect that its orientation shares nothing in common with any of the 16th century or later features so far encountered. This also suggests it be an early feature. The revetment appears to be associated with a fragment of what appears to be surviving walling at its south end. Unfortunately, as the two are not bonded together, this potential association still remains to be proven.

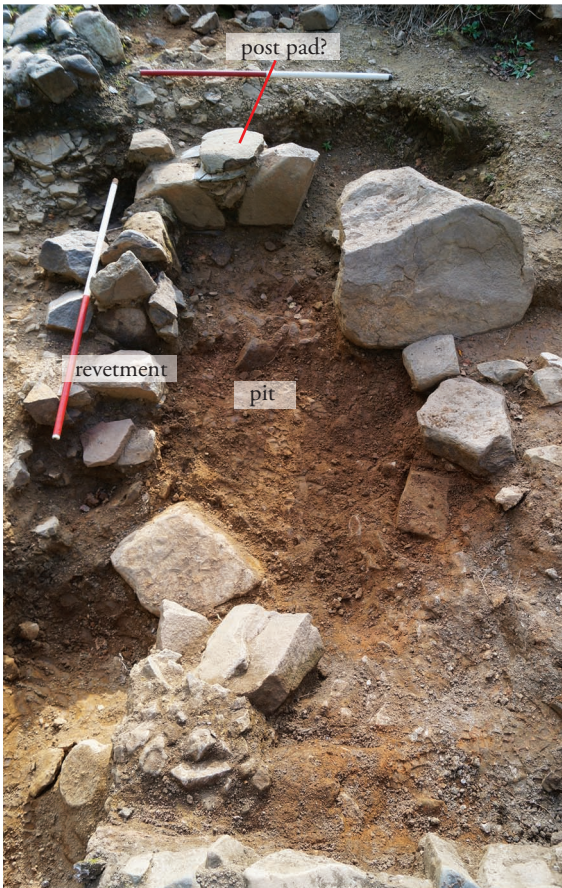
*Photograph 3. Pit dug into sandstone platform with revetted edge and possible post-pad. (I. Ralston)*

Into this platform was cut an irregularly-shaped pit. Its southern side had been revetted and this stonework also made a ninety-degree corner, continuing northwards along part of the west side of the pit. A large boulder was positioned

along the northern edge of the pit and other stones within the pit may have been originally associated with this boulder and the revetment. A well-positioned combination of local slate and small stones formed what might have been a post-pad in the south-west corner (see Photo. 3). Whether this was contemporary with the revetment or a later opportunistic use of it is unknown. Within the south-east corner of the pit a deep hole dug down to meet the sandstone bedrock distorted the plan of the pit. Again, it is not known whether this hole was contemporary or later than the pit. A dense packing of stones within one half of this hole may suggest that it formerly held a post. The pit itself appears to have been deliberately back-filled with rubble containing no finds other than pieces of local slate and small pieces of charcoal. However, at

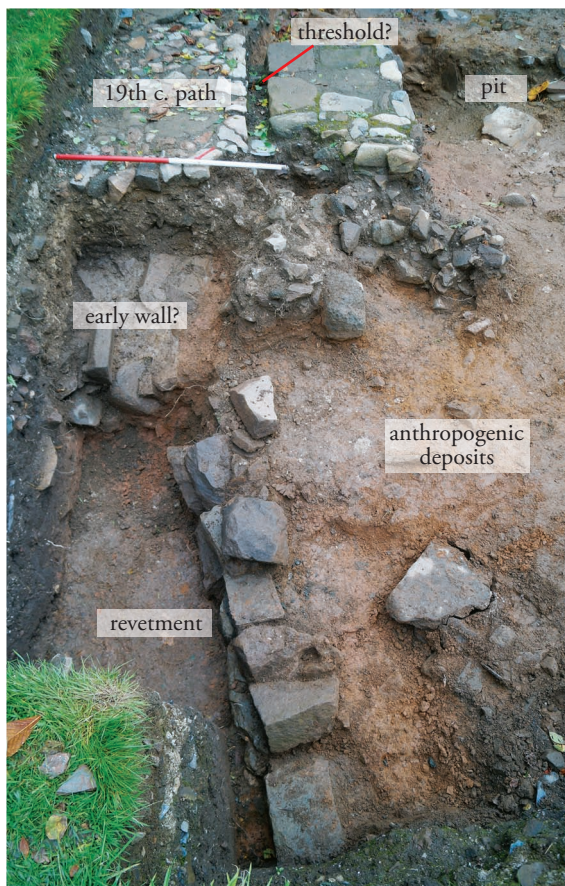
*Photograph 4. View showing site stratigraphy with 19th c. path on top and undated revetment below holding back man-made deposits (I. Ralston)*

In the north-east corner of the site, beneath a deep overburden of mixed soils containing a good amount of 15th/16th century redware, a length of well-articulated revetment was found (see Photo. 4). It appears to have been built to

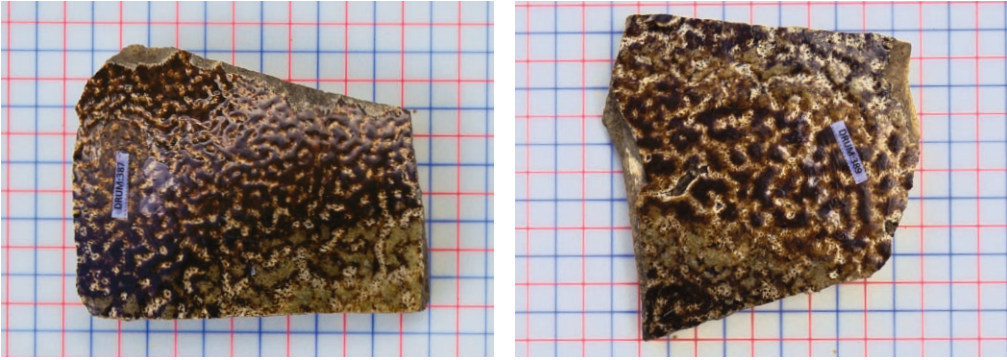
Photographs 5&6. Frechenware from the north range. (All pottery images I Ralston)

Stoneware named after a famous production site near to Cologne (see Photos. 5 and 6). It is characterised by its iron-rich brown surface and salt glaze treatment producing a mottled 'tiger' effect. These are possibly the remains of two vessels, though the distinctive form of these jugs and bottles might well contain a broad range of thicknesses and surface treatment across a single vessel. These vessels are usually dated to between 1550 and 1800. Though presumably coincidental, it is interesting to speculate that Forbes of Menie (owner of Craigievar and known as 'Danzig Willie' or 'Willie the Merchant') was engaged in 17th century commerce in the Low Countries (Greig, 1993, 382). In all, seven fair-sized sherds of this material were found, all from the same context and geographical area within the remains of the north range.

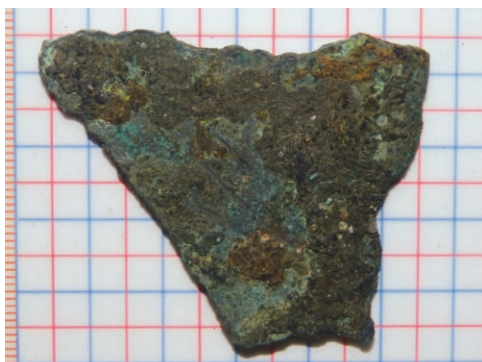
*Photograph 9. Copper-alloy plate. (I Ralston)*

A copper-alloy fragment was found in the bottom of a cut into one of the earliest features on the site, the pit, as described above (see Photo. 9).

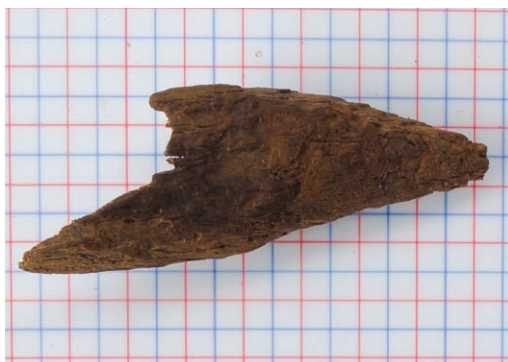
*Photograph 10. Sharpened stake sealed within the north range. (I Ralston)*

Wooden stake point found sealed beneath debris beneath the north wall of the north range (see Photo. 10). The stake was made from a sharpened piece of round wood of indeterminate species.
