DRUMINNOR CASTLE EXCAVATIONS, 2012-2022

INTERIM SUMMARY OF FINDINGS

Colin Shepherd for the
Bennachie Landscapes Project Fieldwork Group
Geology Report by Andrew Wainwright

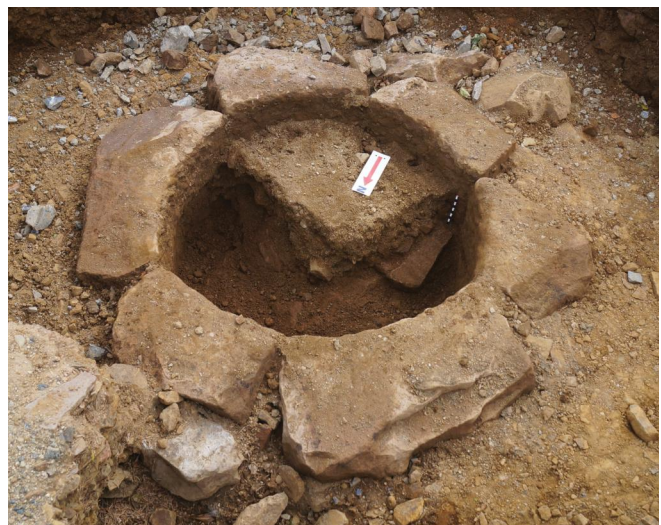
Photo 1. Late medieval well under excavation.

It is believed that the Old Tower was the earliest feature on the site that survived to be recorded, both in drawn and documentary form. It appears to have been built immediately onto basalt and sandstone bedrocks, thus negating the need for any foundations. However, a late medieval well - discovered by geophysics (see Photo 1) - supports other excavated and documentary evidence for the position of the tower. The date of the tower is conjectural but may, arguably, suit a 13th-century horizon, in accord with other towers across the North-east, such as Drum and Dunnideer. The position of the existing hall-house, built in the first half of the 15th century (see below) and hanging out across a scarp overlooking the Kearn Burn, suggests the tower had already been built by that time. The granting of a charter to Duncan de Forbeys in 1271x2 (Ill., AB, iv, 372) may or may not be coincidental to the tower's demonstration of empowerment.

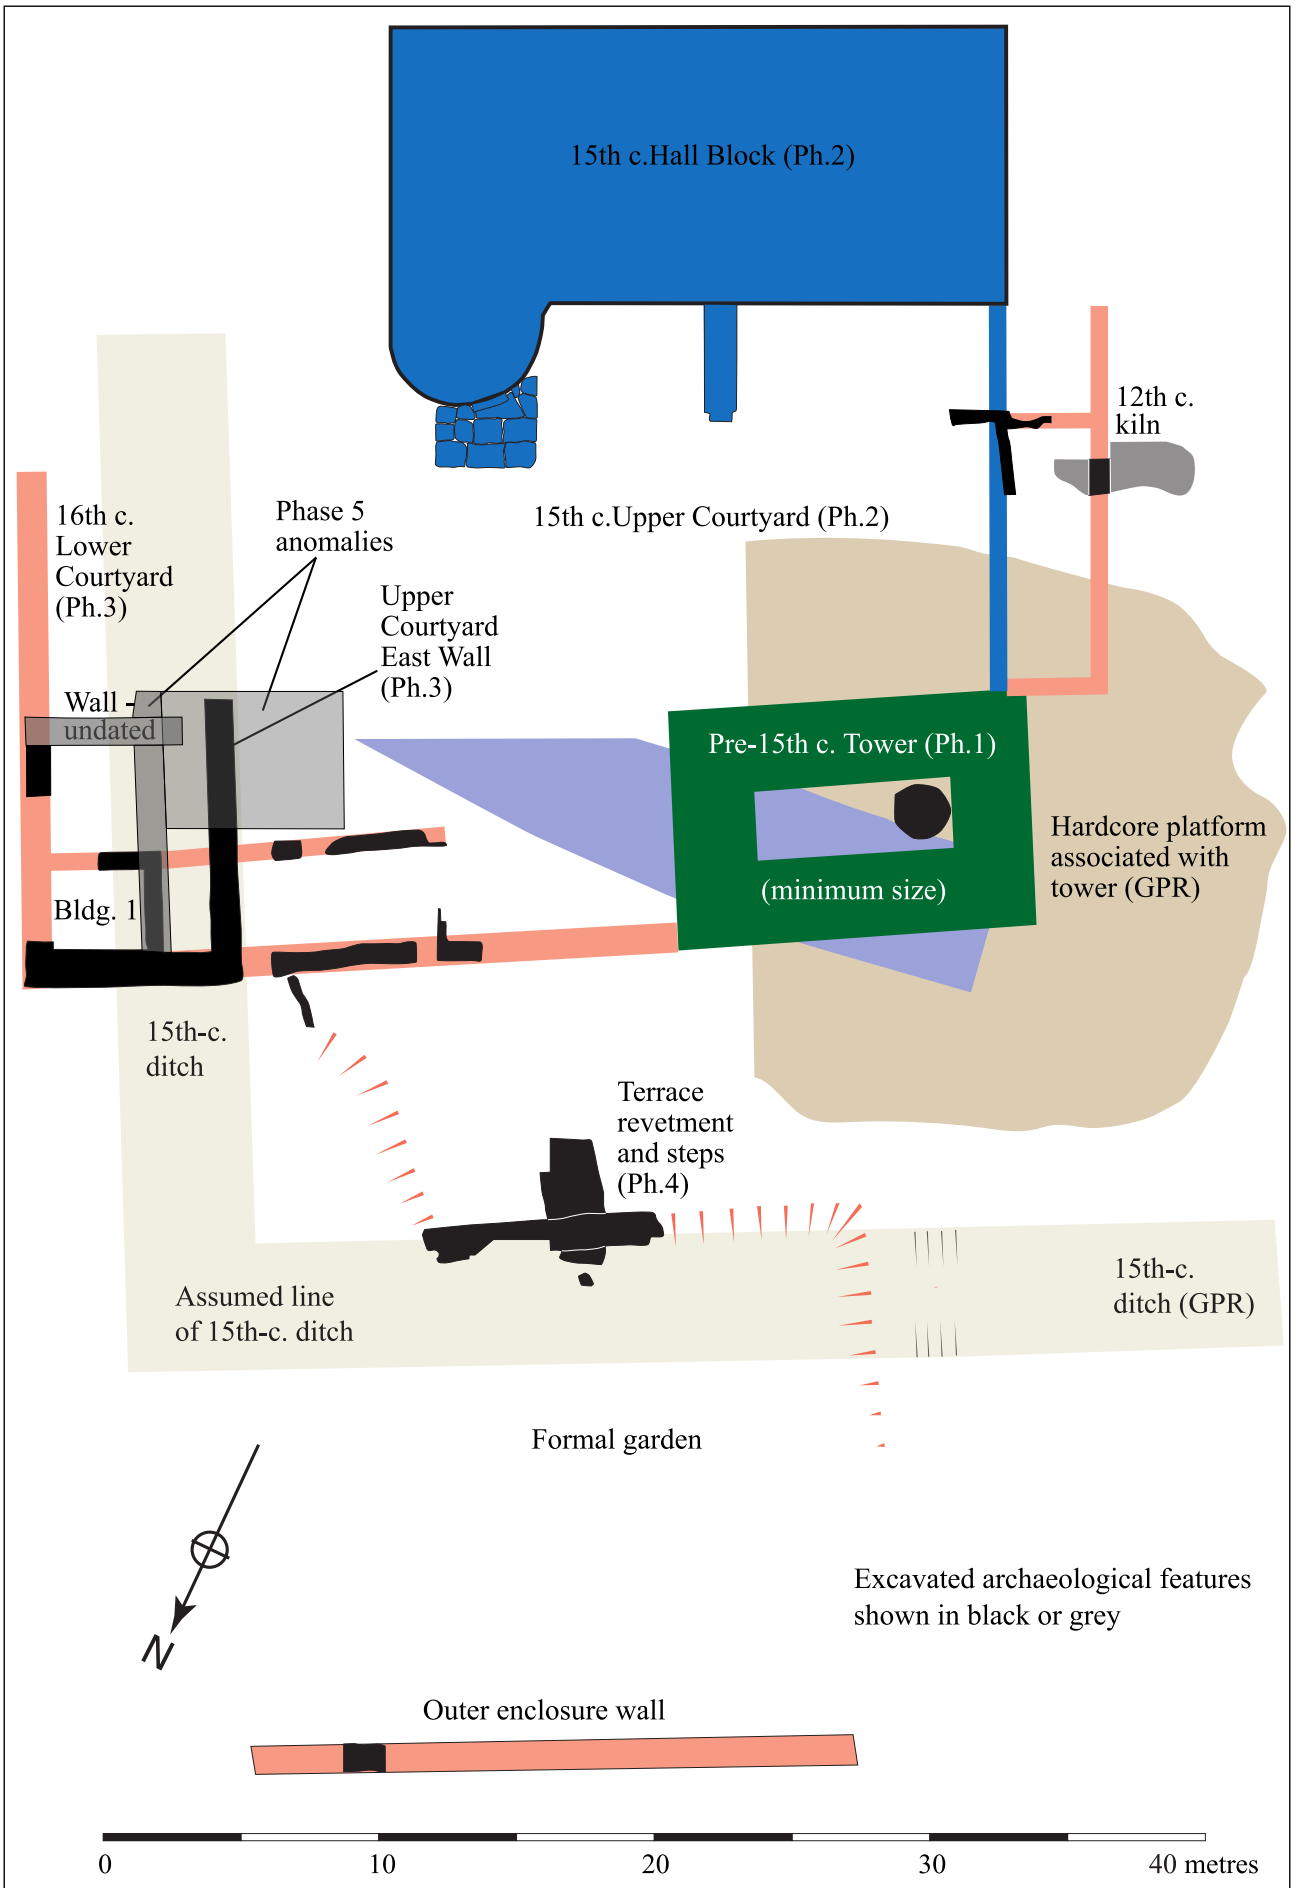
Figure 1. Schematic site plan showing excavated features and suggested dating.

Although no trace of the Old Tower (apart from the well) was found, residual pottery sherds from later deposits suggest habitation on the site during the 13th and 14th centuries. Earlier habitation is attested by a grain-drying kiln but, as this cannot directly be associated with the castle, it will be dealt with separately at the end (see Figure 1).

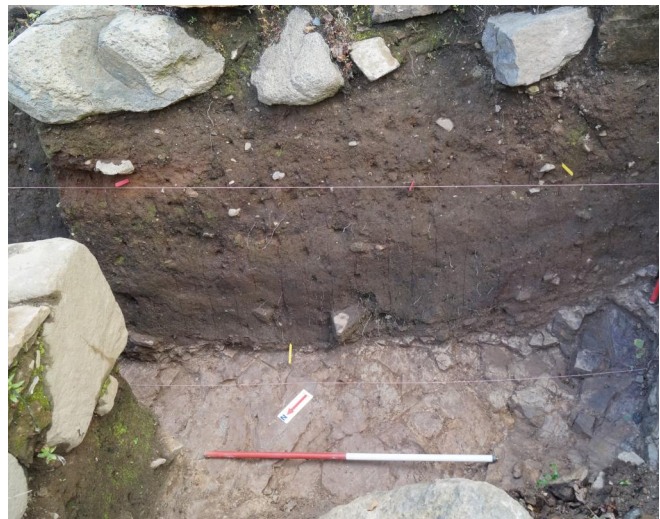
Photo 2. The defensive ditch showing sandstone bedding in base.

The 'skirt' associated with the tower was made from quarried sandstone, packed to create a dense matrix. The 'platform' underlying the rest of the upper courtyard was redeposited sandstone-derived material of a more heterogeneous nature. Although providing a dense and structurally-sound foundation, it lacked the single-source nature of the tower 'skirt'. The former appears to have derived from the immediate surroundings, including from the excavation of the ditch, whilst the latter appears to have been 'brought in' from a purpose-dug quarry.

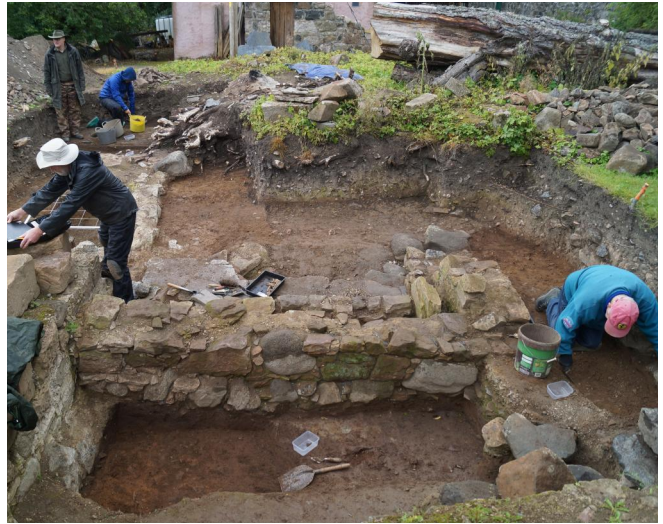
Photo 3. Building 1 under excavation.

defensive ditch. It duly suffered subsidence and was re-built, using the basal part of the first wall as a foundation for its replacement. The building had a series of mortar floors that had, likewise, subsided into the former ditch. This appears to have been a fairly gradual affair with the sunken portion being overlain with subsequent mortar fills in an attempt to try to keep it flat. The rebuilding of the wall may have resulted in the provision of a replacement Correen-slabbed floor and associated drain. Although made with prestigious stone, this was a fairly 'bodged' affair. The drain was not properly tied into the walls of the building. However, the apparent need for a hygienic working area appears to have persisted throughout the life of this building. For this reason, it has been suggested that it may have functioned as a buttry or brewhouse.

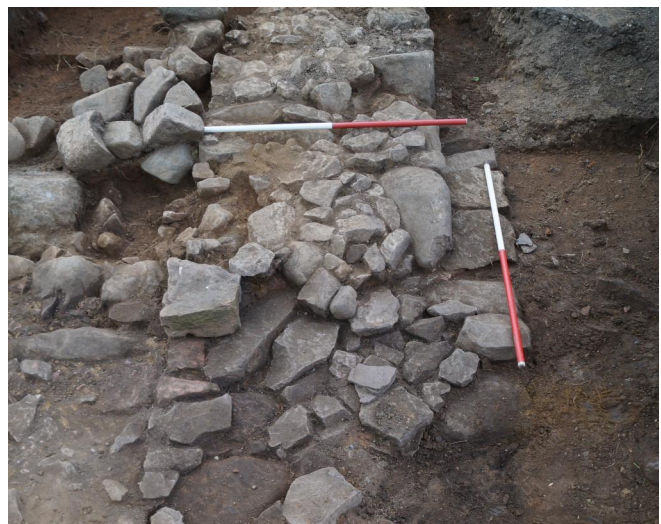
Photo 4. Terrace revetment under excavation.

Parallel to the barmkin wall of the lower courtyard and standing in the walled garden area to the north of it, was a section of well-made wall, abutted by a rectangular platform on its southern side (Photo 4). The construction of these features removed the remains of the defensive ditch in this area. No sign of this robust feature is shown on either of the estate plans drawn c.1770 where this garden area is shown as containing trees. Their construction must, therefore, post-date the use of the defensive ditch and, in turn, have been removed before or during the first half of the 18th century in order to have given time for the trees to have grown. To the north of the wall and its platform was a small scarcement, the same width as the platform. North of this was what appeared to be a post-pad and, beyond that, an area of metalling. In fact, two layers were apparent, separated by a few centimetres of soil. GPR shows these surfaces to be fairly extensive but linearly-aligned roughly east-west.

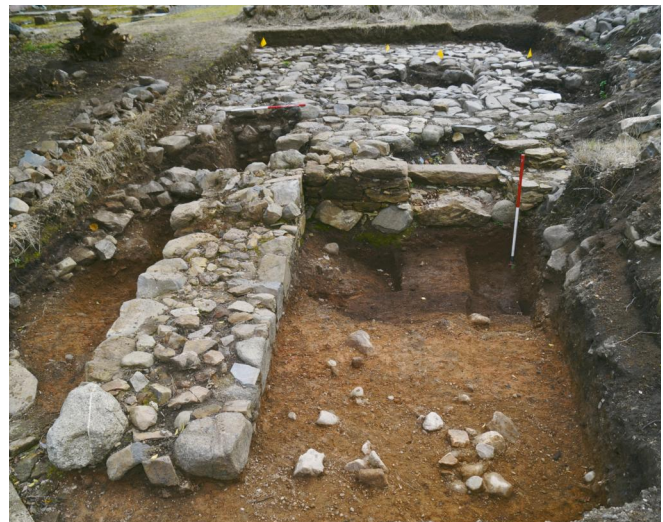
Photo 5. Trench 15 with possible later east barmkin wall (behind vertical ranging rod) abutting cobbled building and former east upper courtyard barmkin sealed by cobbles (beneath horizontal ranging rod).

Interpretation 1 suggests that the later east 'stables' wall may be the east barmkin wall as shown on the estate plans. This would make the measurements of those plans quite inaccurate. However, the stables would fall

in the correct relative place as a building shown on those estate plans. Furthermore, the wall sealed by the cobbling - itself, very substantial and bound by mortar - appears not to be referenced at all on either estate plan, though its construction seems to be similar to the north barmkin wall of the lower courtyard. Had the wall been standing at that time of the estate plan surveys, it might be considered unlikely that it would not have been depicted. Finally, Building 1 in the north-east corner of the lower courtyard is also not referenced at all on the estate plans. The suggestion, therefore, is that the estate plans depict a reduced castle footprint and that, formerly, the lower courtyard had extended further to the east by approximately 4 metres.

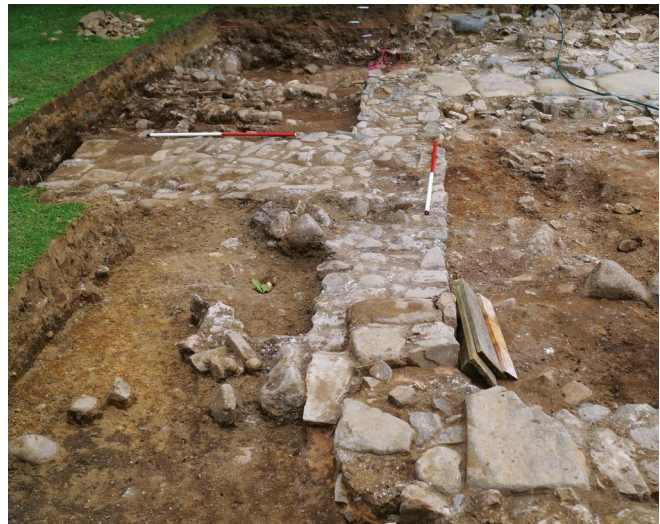
Photo 6. Early 19th-century garden cobbling.

19th-century garden planning was recognised in the form of narrow garden pathing recovered in the earliest years of the excavations. One of these respected the line of the former north barmkin wall, which showed that it had to be in existence while that wall was still standing (Photo 6). Also, parts of the north wall that did survive had to have been above ground level at that time - only subsequently being covered by later 19th-century landscaping. More recent excavation inside the line of the former west range also show the same pattern of early 19th-century cobbling - sealing late 18th-/early 19th-century pottery and glass - respecting the line of the former courtyard wall. It would seem, therefore, that the demolition of 1800 may have left elements of the former upper courtyard to be re-used as a new enclosed garden area.

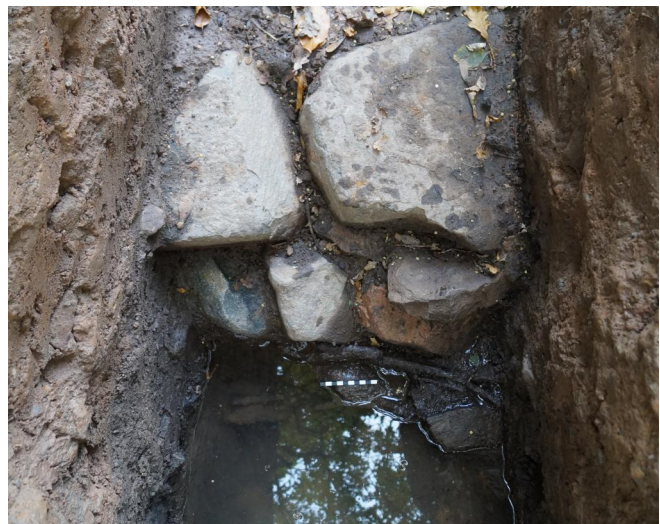
Photo 7. Revetment with possible wickerwork remains.

In front of the wall on its northern side was the course of a former small burn or ditch. The edges of this had been prepared with a clay embankment on the southern side and stone revetting along its northern edge (Photo 7). During excavation the former burn filled with water and had to be repeatedly emptied. The burn would have formerly helped to drain the fields lying along its northern side. Small rods of wood caught in the revetment stones may have been the remains of a wickerwork structure or simply twigs caught in the stones whilst the burn was still open.

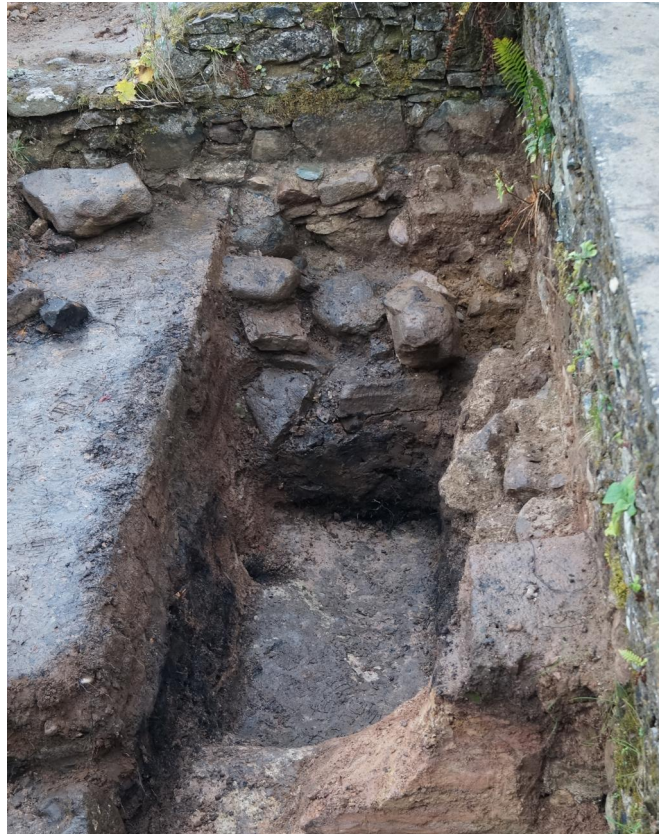
Photo 8. Kiln showing burnt grain deposit and infilling stones.

The kiln is similar to the 'keyhole' structures found at Nottingham (Knight, 2015), Hoddum (Lowe, 2006) and, more locally, at Inverness (Ellis, 2002). The bowl and flue of the kiln were cut steeply into an extremely friable Devonian sandstone (Photo 8). C14 analysis of a charred grain (*Avena* sp.) from the base of the kiln returned a date of 1035 - 1207 calAD at 95% probability (SUERC-67036). This tallies fairly well with a date of 1158 - 1262 at 95% (SUERC-76174) for a fragment of birch from one of the post holes in the bottom of the kiln and suggests a realistic date during the second half of the 12th century. These dates also appear to conform to the architecturally-similar examples found at Nottingham, Inverness and Hoddum. The Druminnor kiln had no stone lining as became common in later times, though, at Abercairney, stone-lined kilns can be seen to have

been already in use from the mid-11th century (Gibson, 1989). The friable nature of the sandstone bed into which the Druminnor kiln had been quarried permitted the digging of the bowl into a stable geological layer. Other beds recognized across the site would have been much harder or softer, suggesting that this bed may have been selected for its potential architectural attributes. The Devonian bedding is clearly visible within its matrix. However, once open to the elements, these beds weather and crumble quite quickly, but does not drain well. In other words, the kiln would have required some form of roofing.

The environmental evidence, described at length elsewhere (Robertson in Shepherd, 2018), suggests that the large stones found in the fill of the kiln's bowl were formerly structural elements; they were associated with scorched clay and charred grain. As their shape and size prohibits their interpretation as being associated with a lining for the kiln, they may have been associated with its superstructure. This would, therefore, lead to the possibility of a stone-built kiln. Such a structure would certainly have helped in limiting the risks of total destruction by fire.
